Manhole Inspection Summary

Manhole # S07KK1014MH

Insp Date: **1/20/09 2:54 PM**

Location Address: **REAR - 3740 MANCHESTER AVE**

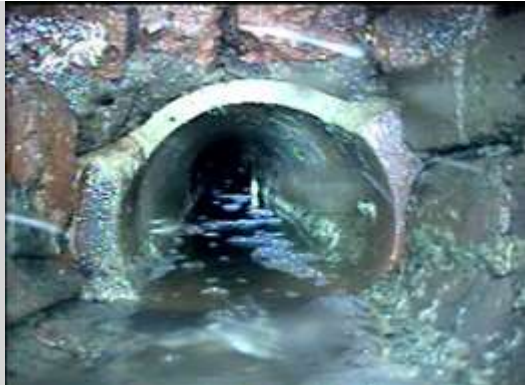
12 O'Clock Outflow

8 in. Circular Gravity Sewer
Pipe Out @ 12 O'Clock

Invert Depth: **7.66** (ft.) Flow Characteristics: **Slow**

Infiltration: **None** Pipe Seal Cond: **Unknown**

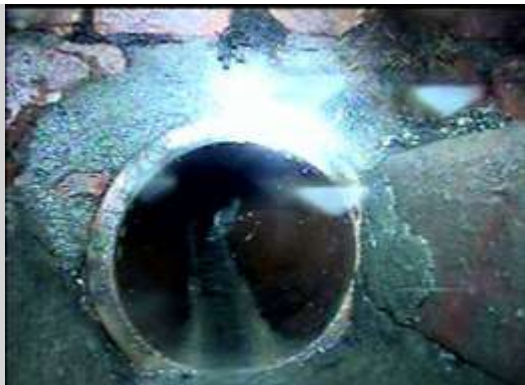
3 O'Clock Inflow

6 in. Circular Gravity Sewer
Pipe In @ 3 O'Clock

Infiltration: **None** Pipe Seal Cond: **Sound**
